Commercialization of LIBS for Lead-in-Paint Inspection

Abstract: A study was undertaken to determine if laser-induced breakdown spectroscopy (LIBS) can be a practical and competitive alternative to X-ray fluorescence (XRF) methods for lead-in-paint inspection. Experiments in the laboratory confirmed that LIBS is suitable for detecting lead in paint at the hazard levels defined by federal agencies. Although we compared speed, function and cost, fundamental differences between the XRF and LIBS measurements limited our ability to make a quantitative performance comparison. While the LIBS method can achieve the required sensitivity and offers a way to obtain unique information during inspection, the current component costs will likely restrict interest in the method to niche applications. ©

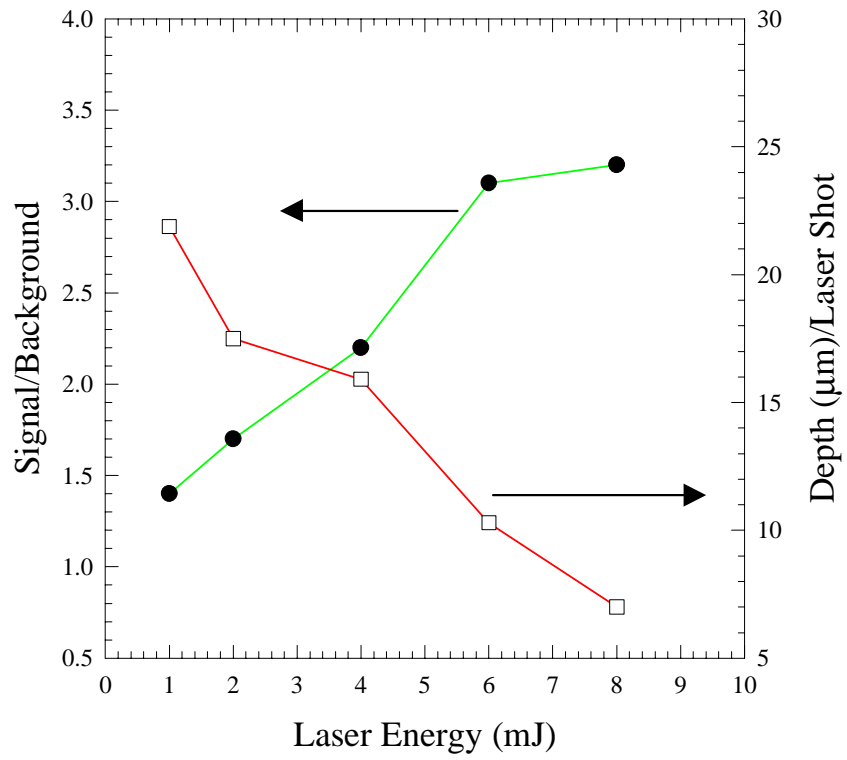
Figure 2

Figure 2. The Pb emission signal to background ratio of paint increases as a function of laser energy, but the penetration depth per laser pulse decreases with increasing energy. This decrease is likely due to plasma screening. Data was collected using the cooled CCD and ¼-m spectrometer.

To assess LIBS as an alternative to XRF for rapid, on-site paint inspection, we optimized the amount of material removed during each laser pulse. As seen in Figure 2, while the signal to background ratio increased with laser energy it began to saturate when the pulse energy exceeded 15 mJ and the penetration depth of each laser shot decreased. This phenomenon was observed in all of the paints tested and the decrease in penetration depth with laser energy was attributed plasma screening [17, 18]. This occurs when the intense plasma spark prevents the tail end of the laser pulse from interacting with the target. In addition, the plasma ablation formed craters with diameters from $<100\ \mu\text{m}$ to over $500\ \mu\text{m}$ as the laser pulse energy was increased across the tested range. Using this data, we determined that a pulse energy between 6 and 8 mJ provided the best trade-off between the strength of signal and removal rate.

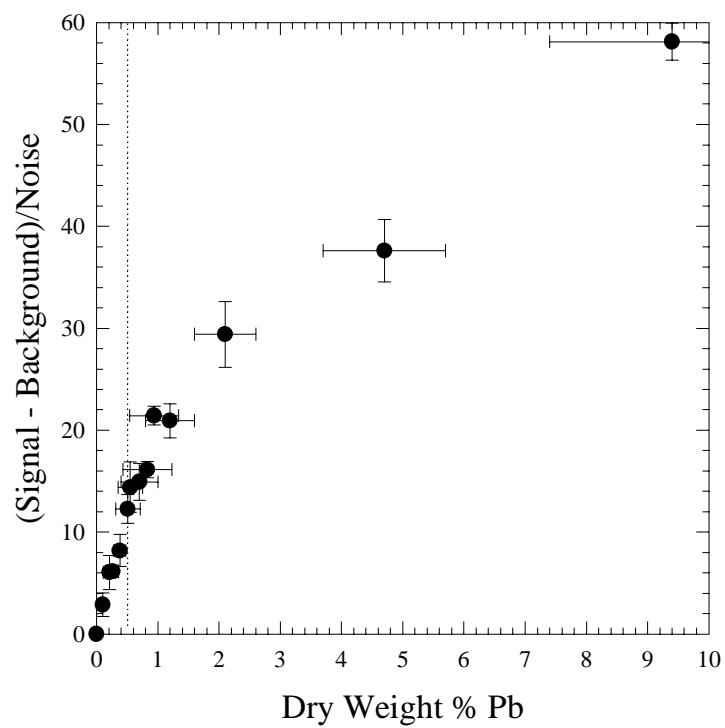
Figure 3. Signal to noise ratio as a function of the dry wt. % of PbCO_3 added to a commercial latex paint. The measurements were performed at 7 mJ with a cooled CCD detector. Data was recorded following averaging of six laser shots. The federal guideline of 0.05 dry wt. % of Pb (5000 ppm) is noted with a dashed line. Concentration errors result from sample preparation and achieving homogeneous blending. Data was collected using the cooled CCD and ¼-m spectrometer.

Figure 3 shows the measured Pb emission signal arising from LIBS experiment using paint samples with PbCO_3 concentrations ranging from 0.1 wt. % to 10 wt. %. The strength of

the emission signal from Pb was recorded by averaging the signal generated with six laser shots and laser pulse energy of 7 mJ. Several random sampling locations were selected for each measurement to determine the signal uniformity and measurement error across each sample. The figure indicates that, at the HUD federal abatement level of 0.5 wt. % Pb, at least a 10:1 signal-to-background ratio can be achieved. The response was linear at this federal action level, which is important for achieving accurate measurements. We measured these samples with RMD's XRF instrument but a comprehensive comparison was not realized because the relatively thin paint layers resulted in readings below the maximum reliable sensitivity of the instrument (0.3 mg/cm²). A separate measurement of the Pb sample using a more sensitive XRF instrument showed that our estimates were accurate for the purpose of our study with error towards overestimating the concentrations.

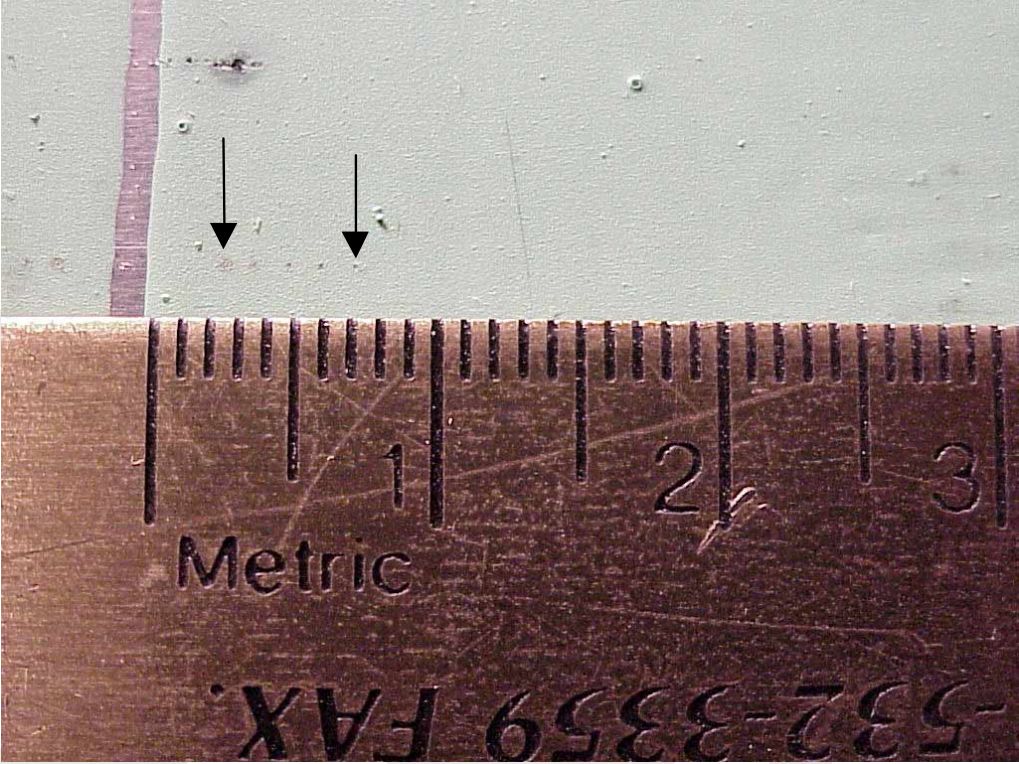
Figure 5. Picture of the paint crater created by the LIBS process. Each was formed with four laser shots. The laser energies range from 28.4 mJ (indicated with an arrow on the left) to 2.2 mJ (indicated with an arrow on the right). The smallest crater has a diameter of $\sim 75 \mu\text{m}$. The paint was applied to an Al substrate and typical paint imperfections can be seen. The region above the arrow on the left was formed with over 100 laser pulses and has a dark ring from ablation of the Al.

The XRF measurement is non-destructive and non-marking, making it attractive for many Pb-paint inspection needs, especially for home sale surveys. In an effort to anticipate the consumer response to the more destructive LIBS method, we evaluated the laser damage spot following sampling. For nearly all of our test cases, the damage area was no larger than 0.5 mm in diameter and typically closer to 100 μm . The visual impact of the damage site increases when the laser penetrated deep into the substrates resulting in slight darkening around the crater perimeter. Figure 5 shows a picture of a test sample following sampling with various laser intensities used to penetrate a layer of paint. It is apparent that the LIBS method may be

controlled to prevent damage beyond the many common surface imperfections also seen in the image. In addition, it is much less destructive than sampling for laboratory analysis. Finally, because paints have a high degree of homogeneity, a LIBS-based instrument is not expected to require a greater number of sample locations than XRF despite its small sampling volume.
